**MINIMUM INSPECTION PROCEDURAL GUIDELINES  
FOR BUILDING STRUCTURAL RECERTIFICATION**

**CASE REFERENCE NUMBER:** US 2023-04402

| 1. DESCRIPTION OF BUILDING | |
|---|---|
| a. Name on Title: Delkus Towers Condominium Assoc., Inc. | |
| b. Building Street Address: 6725 Harding Avenue, Miami Beach, FL 33141 | Bldg.#: |

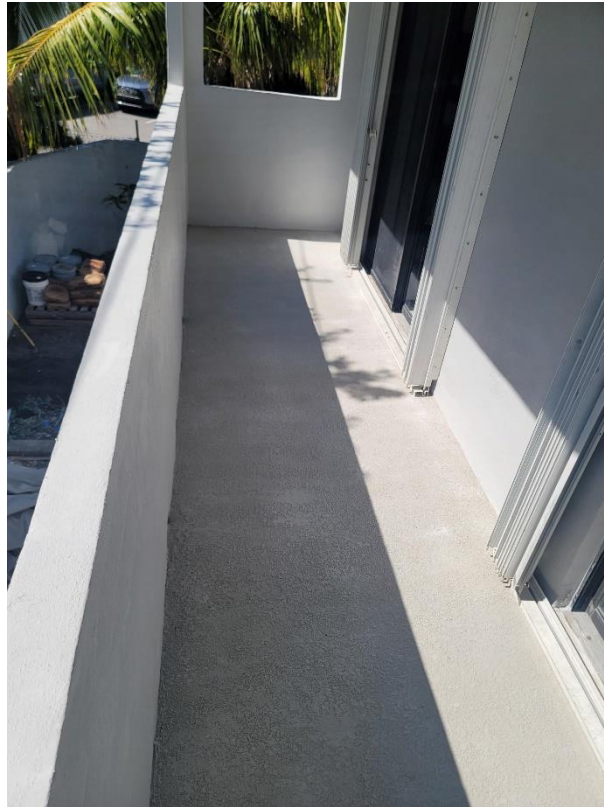
**Photo #3 – Freshly Painted and Waterproofed, Recently Repaired Balcony**

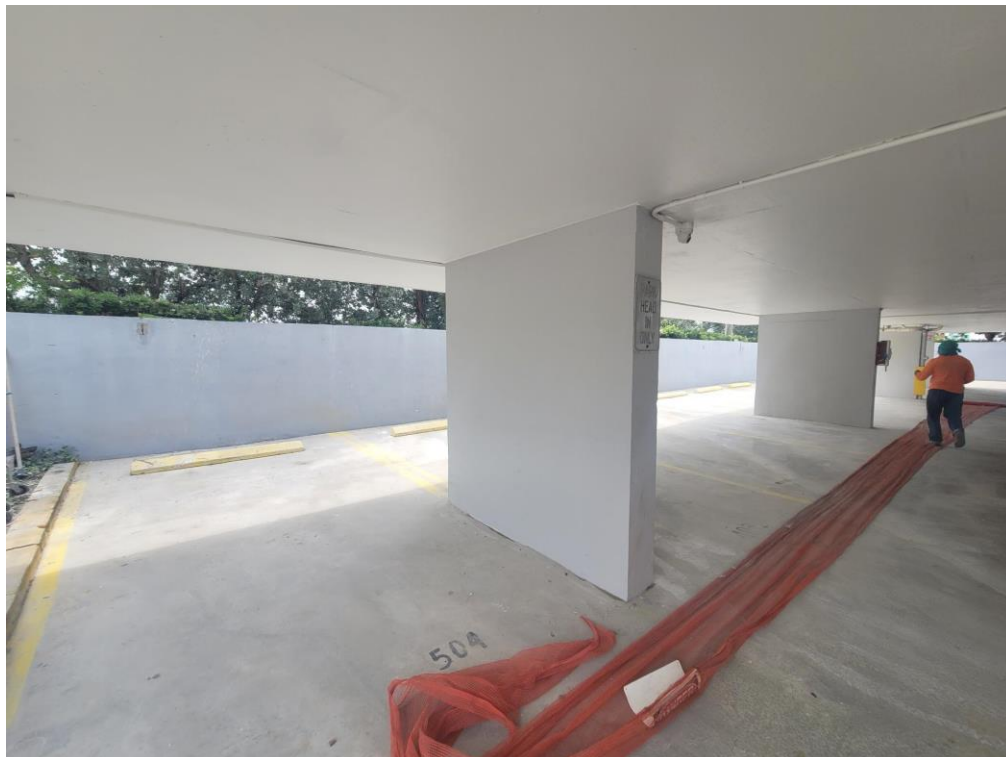
**Photo #4 – Freshly Painted Covered First Floor Parking Under the Building**

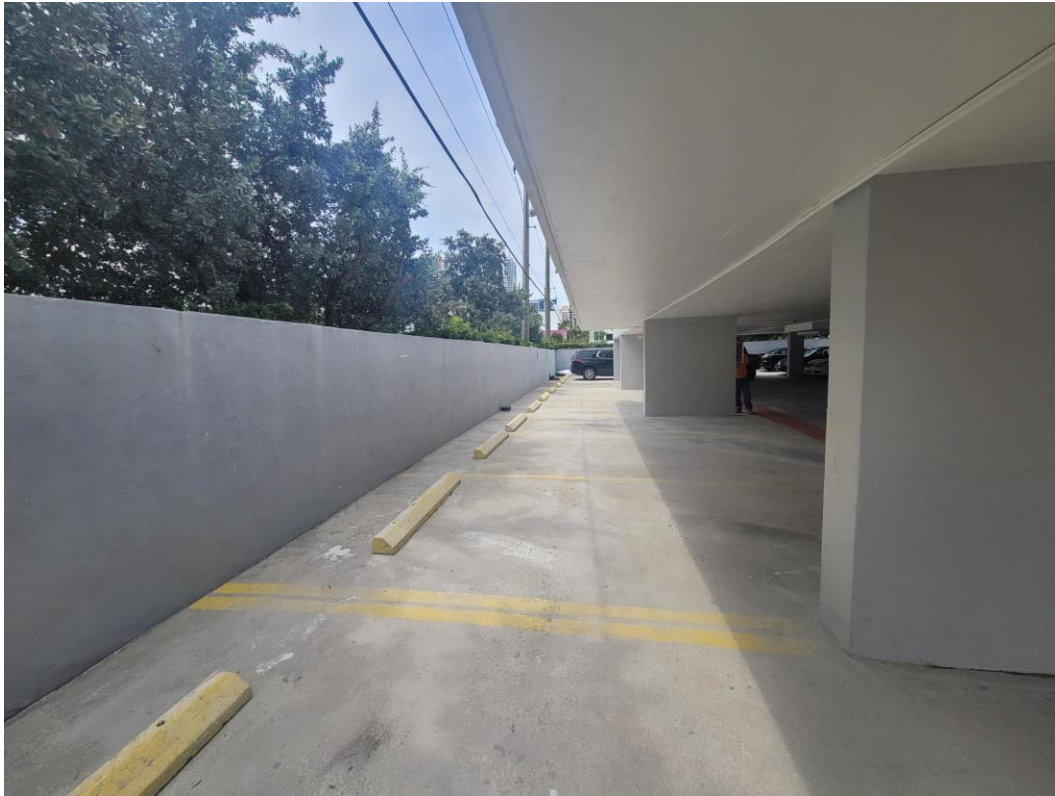
**Photo #5 – Freshly Painted and Waterproofed, Fully Repaired Balcony Underside**

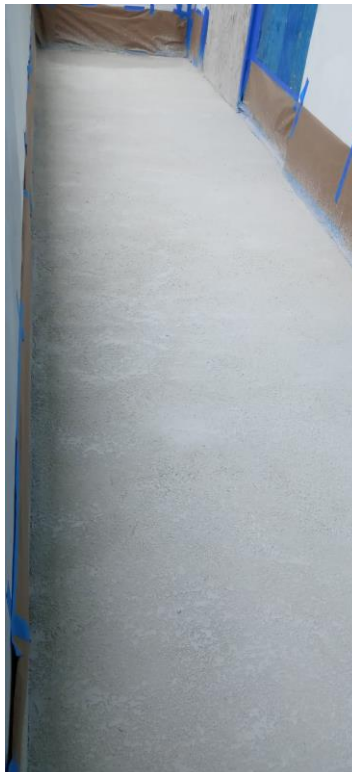
**Photo #6 – Freshly Waterproofed Balcony Deck Surface**
